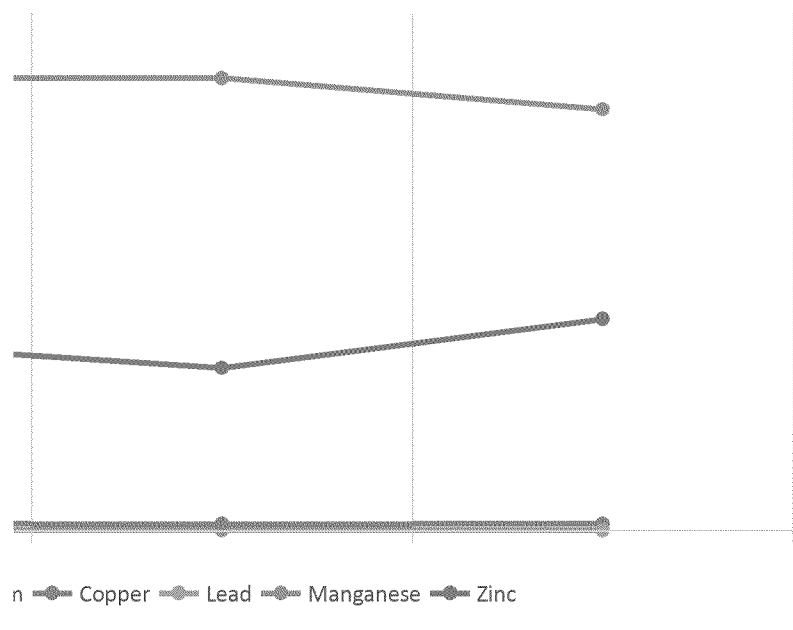
Location: 32nd Street Bridge

ocation ID	Date Sampled	Cadmium	Copper	Lead	Manganese	Zinc
32nd St Br	8/5/2015	0.178	1.7	0.24	105	43.5
32nd St Br	8/6/2015	0.16	1.56		105	37.8
32nd St Br	8/6/2015	0.19	1.62	0.115	97.8	49.1

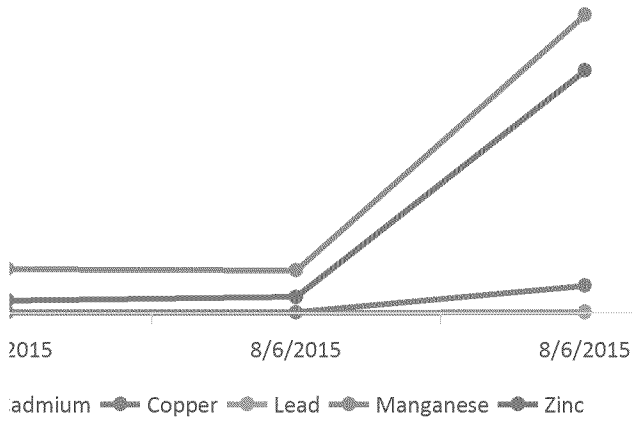
Location: Bakers Bridge

ocation ID	Sampled	Cadmium	Copper	Lead	Manganese	Zinc
Bakers Bri	8/5/2015	0.353	2.28		306	85.8
Bakers Bri	8/6/2015	0.336	1.88		296	110
Bakers Bri	8/6/2015	5.32	189	1.56	2090	1700

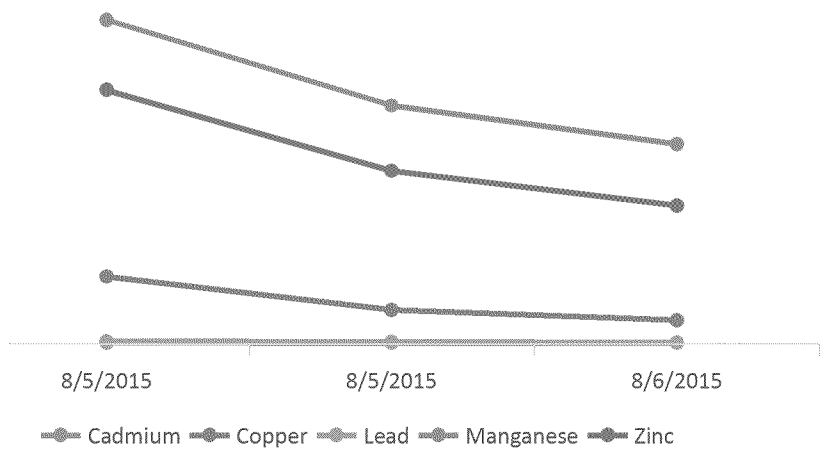
Location: CC48

ocation ID	Sampled	Cadmium	Copper	Lead	Manganese	Zinc
CC48	8/5/2015	30.6	2260	73.9	10900	8540
CC48	8/5/2015	19.1	1130	54.1	8020	5820
CC48	8/6/2015	14.2	786	30	6720	4650
